Manhole Inspection Summary

Manhole # S41A2_016MH

Insp Date: **12/7/07 12:26 PM**

Location Address: **3745 Saint Victor St** Cross Street: **Washburn Ave.**

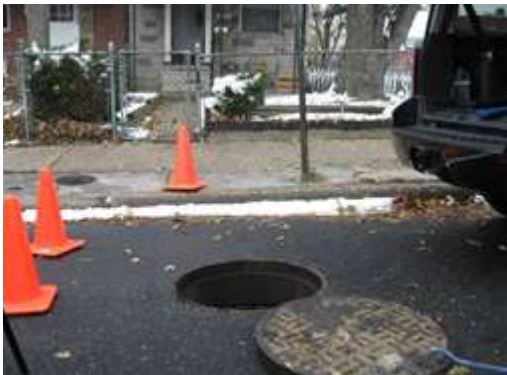
Location View

St. Victor

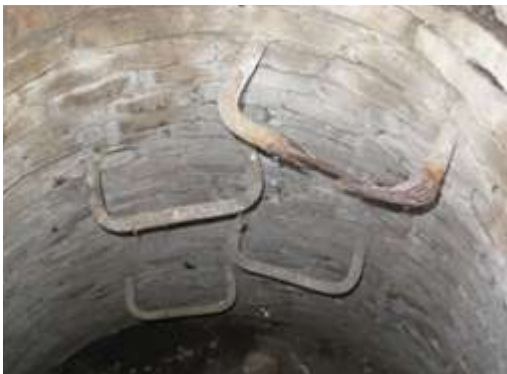
Steps Count: **4** Missing: **0** ☒ **Corroded**

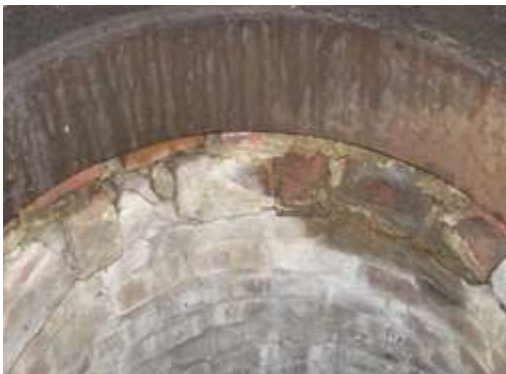
Defect 1

Chimney / Frame Adjustment ☒ Exists Material: **Brick** ☐ Parged Height: **0** (in.)
Condition: ☒ Sound ☐ Cracked ☐ Root Intrusion ☐ Loose Brick ☐ Deteriorated
Infiltration: ☐ None ☐ Joint ☐ Cracks ☒ **Mortar** ☐ Roots ☐ Wall

Corbel Material: **Brick** ☐ Parged Type: **Concentric/Eccentric**
Condition: ☒ Sound ☐ Cracked ☐ Root Intrusion ☐ Loose Brick ☐ Deteriorated
Infiltration: ☐ None ☐ Joint ☐ Cracks ☒ **Mortar** ☐ Roots ☐ Wall

Mortar

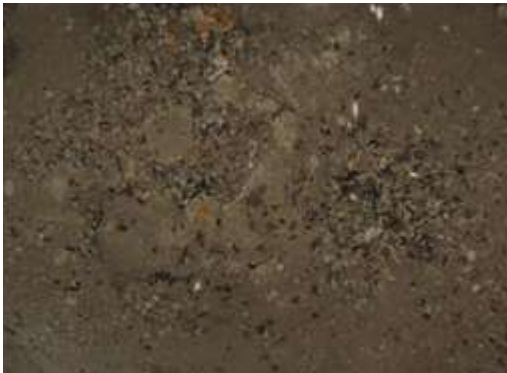
Defect 2

Debris

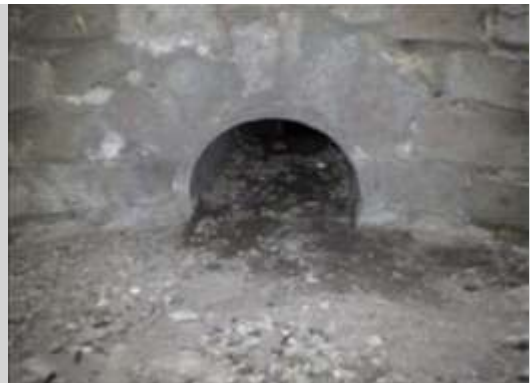
12 O'Clock Outflow

8 in. Circular Gravity Sewer
Pipe Out @ 12 O'Clock
